<b>A1</b>	Trouble-shooting program	
-----------	--------------------------	--

## 1. Special features

Test specifications

Opel

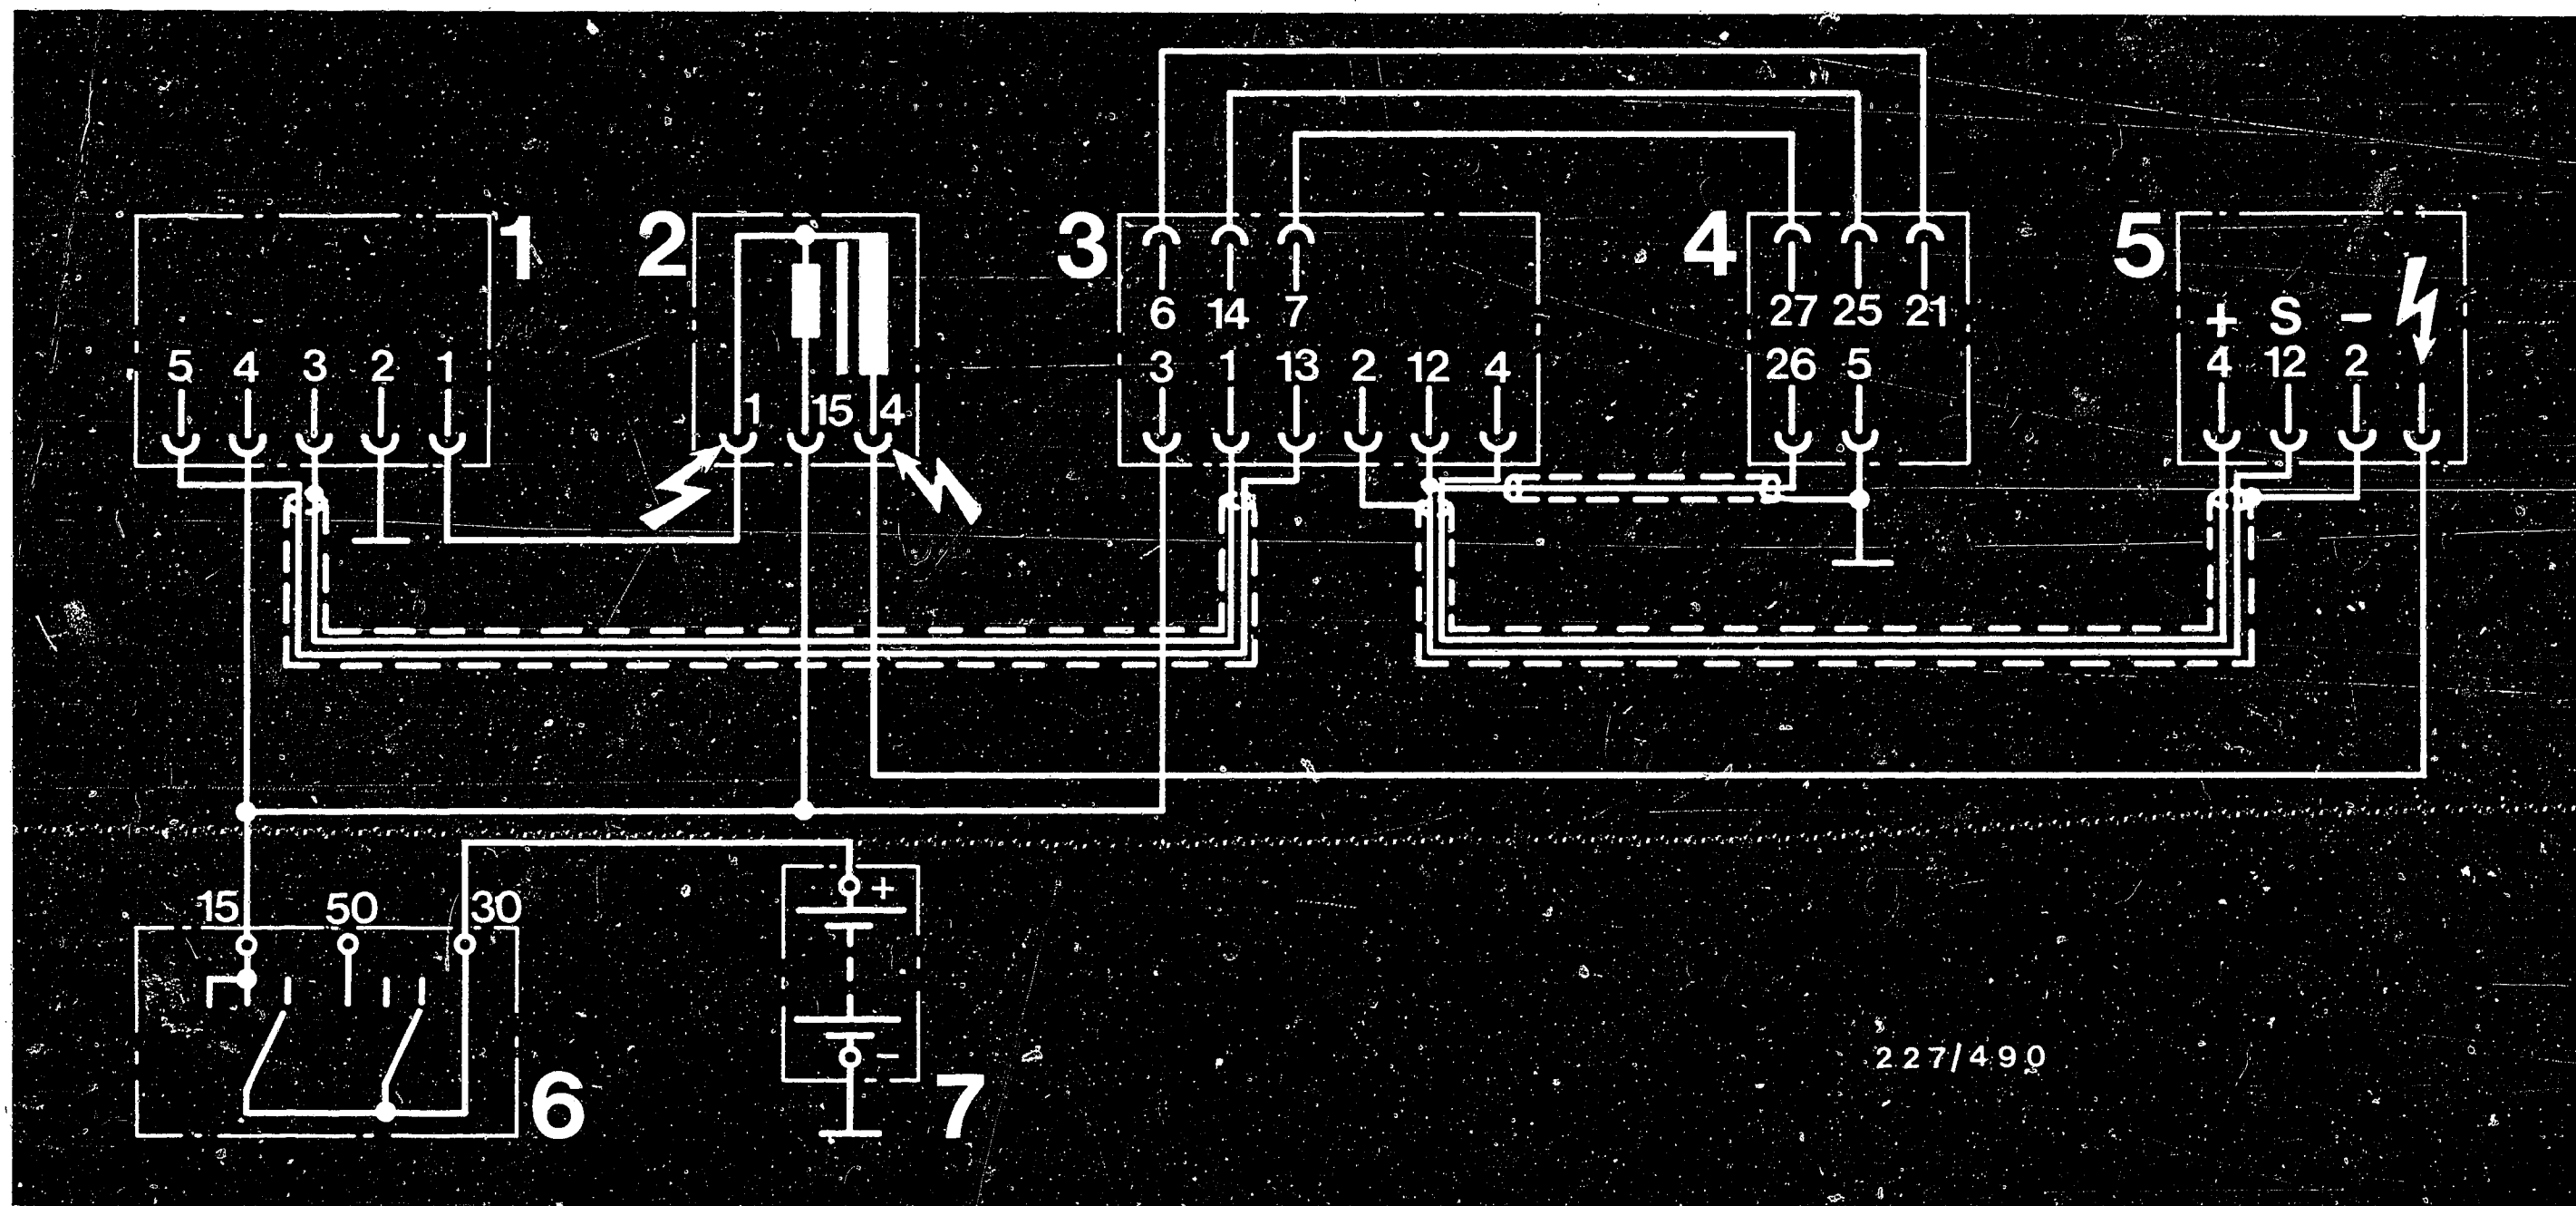
⚡ = dangerous voltages  
(400 V - 25 kV)

1 = Ignition trigger box  
2 = Ignition coil  
3 = Timing advance device  
4 = Ecotronic control unit

5 = Ignition distributor  
6 = Ignition-starting switch  
7 = Battery

### 3. Electrical connection diagram

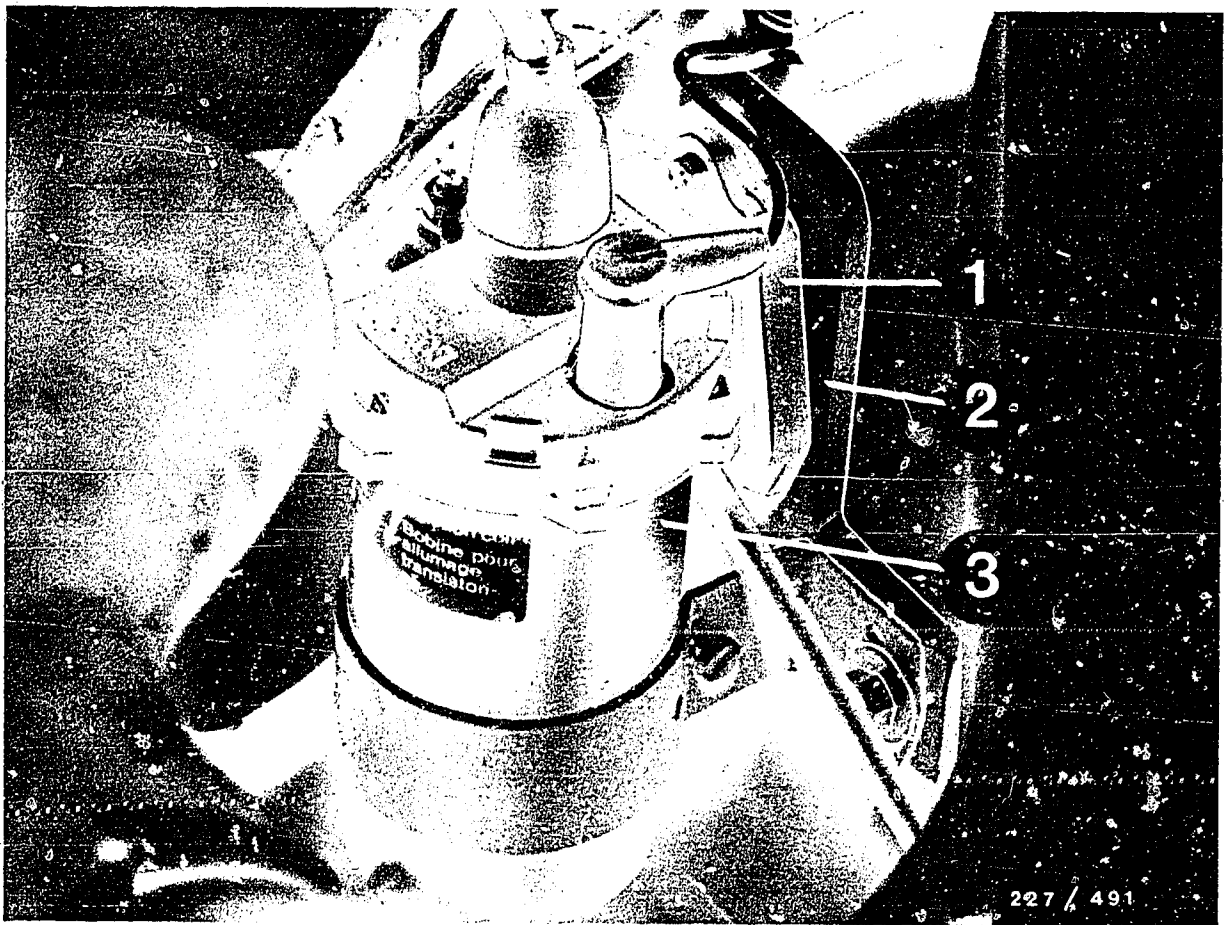
- 1 = TI trigger box
- 2 = Heat sink
- 3 = Ignition coil

The trigger box and ignition coil are mounted on a common heat sink. See picture.

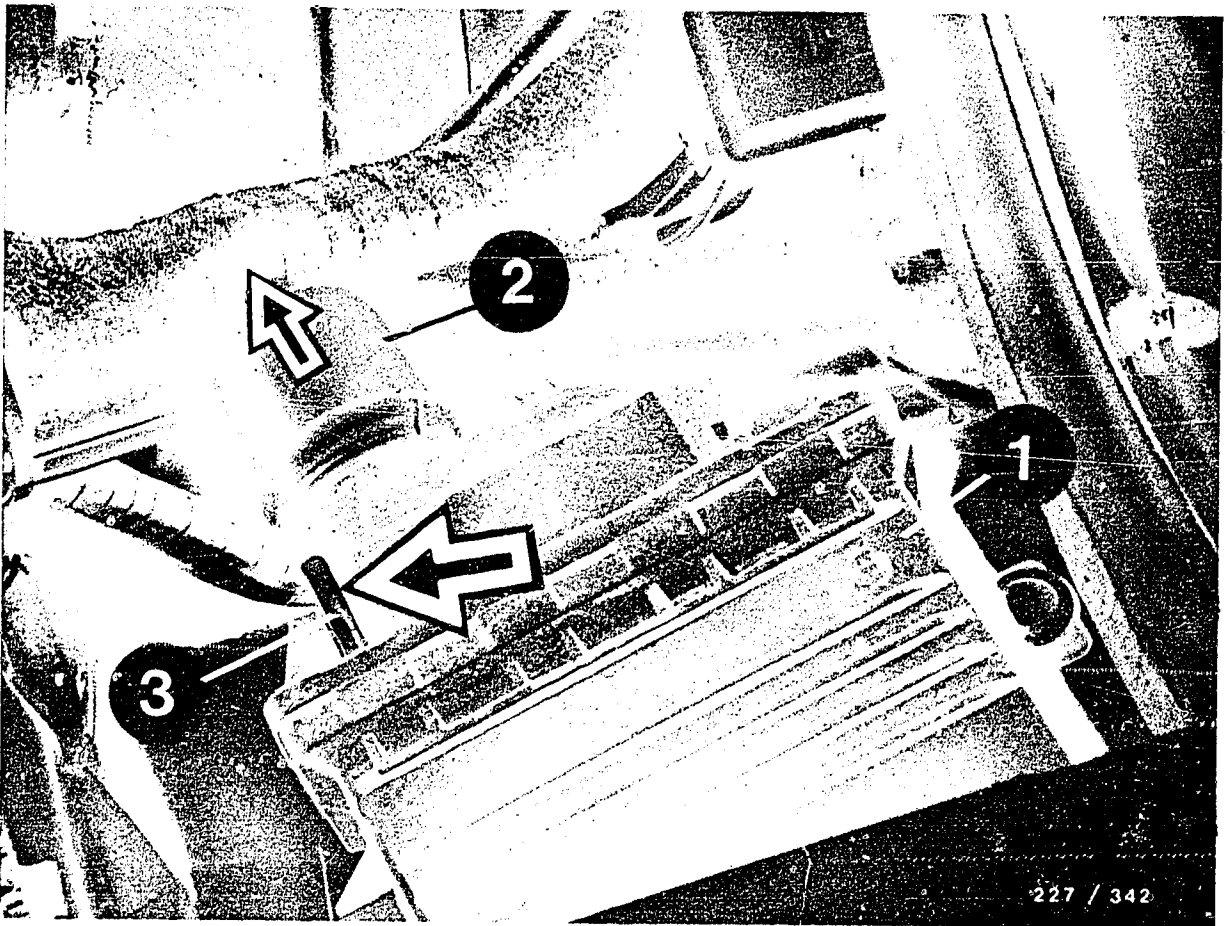
- 1 = Timing advance unit
- 2 = Timing advance unit plug
- 3 = Detent

The timing advance unit is on the wheelbox on the left-hand side in the forward direction of travel. See picture.

Press detent for timing advance unit plug in direction of arrow, and hinge plug in direction of arrow.

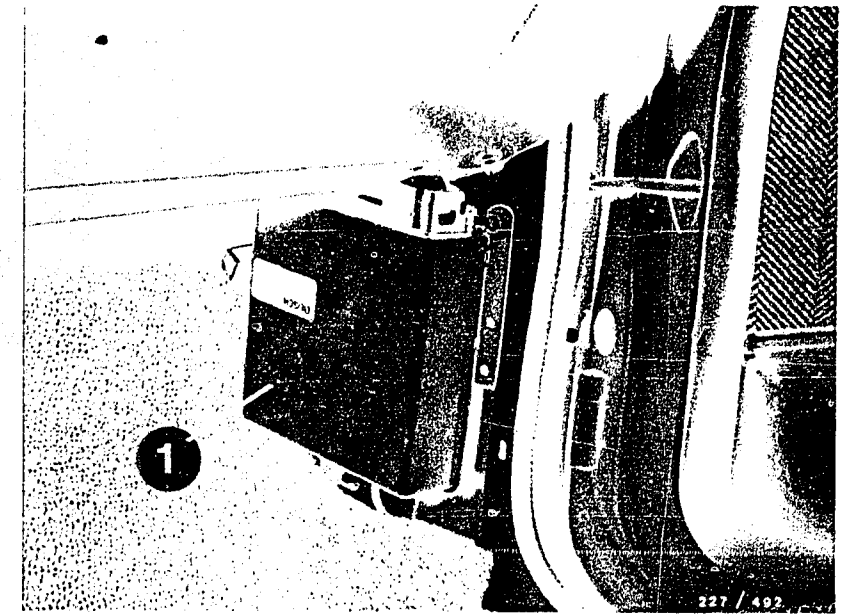
Pull out the plug (arrow, figure at bottom) and take off the side wall panel.

1 = Ecotronic control unit

2 = Side panel

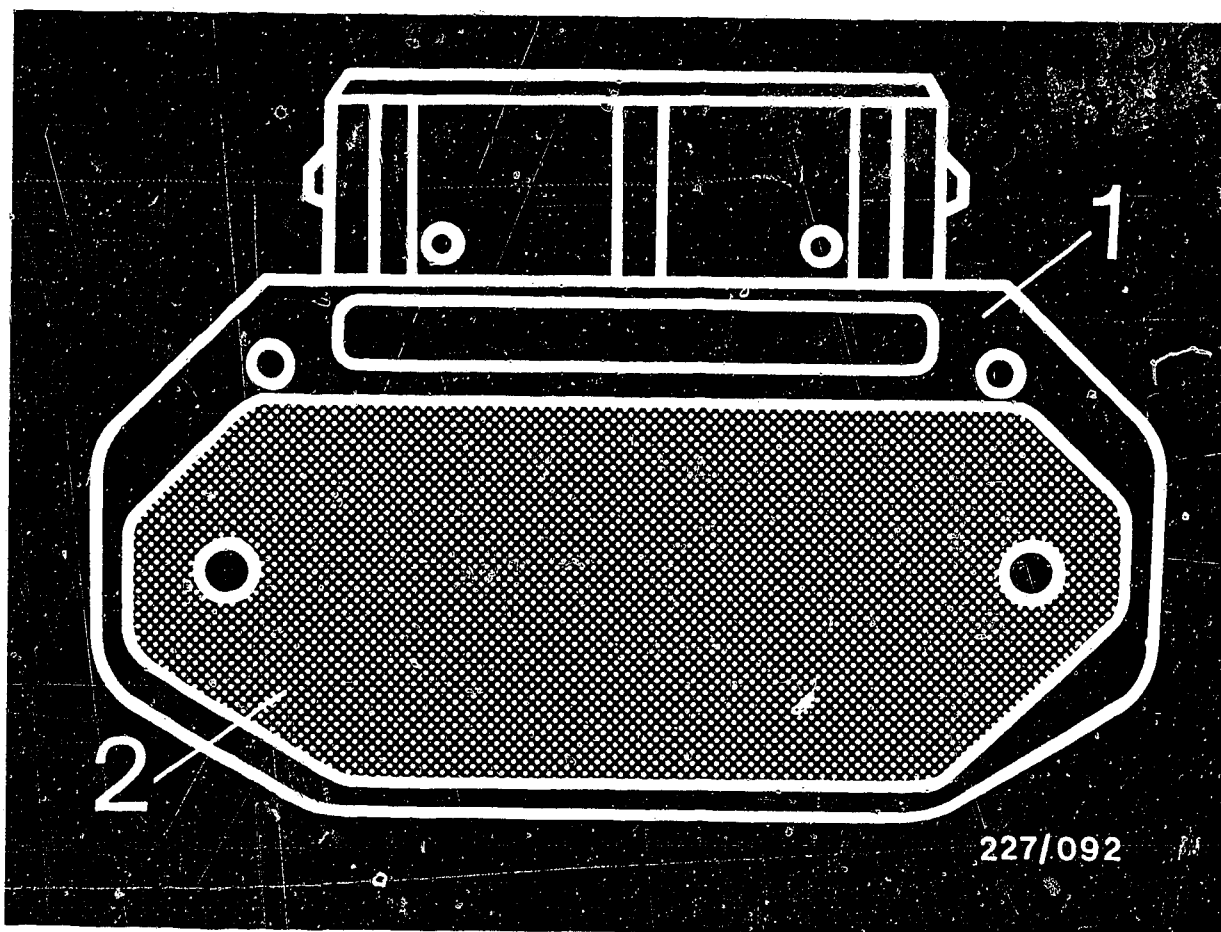
1 = Trigger box

2 = Base plate

Do not apply thermal conduction paste to painted parts.

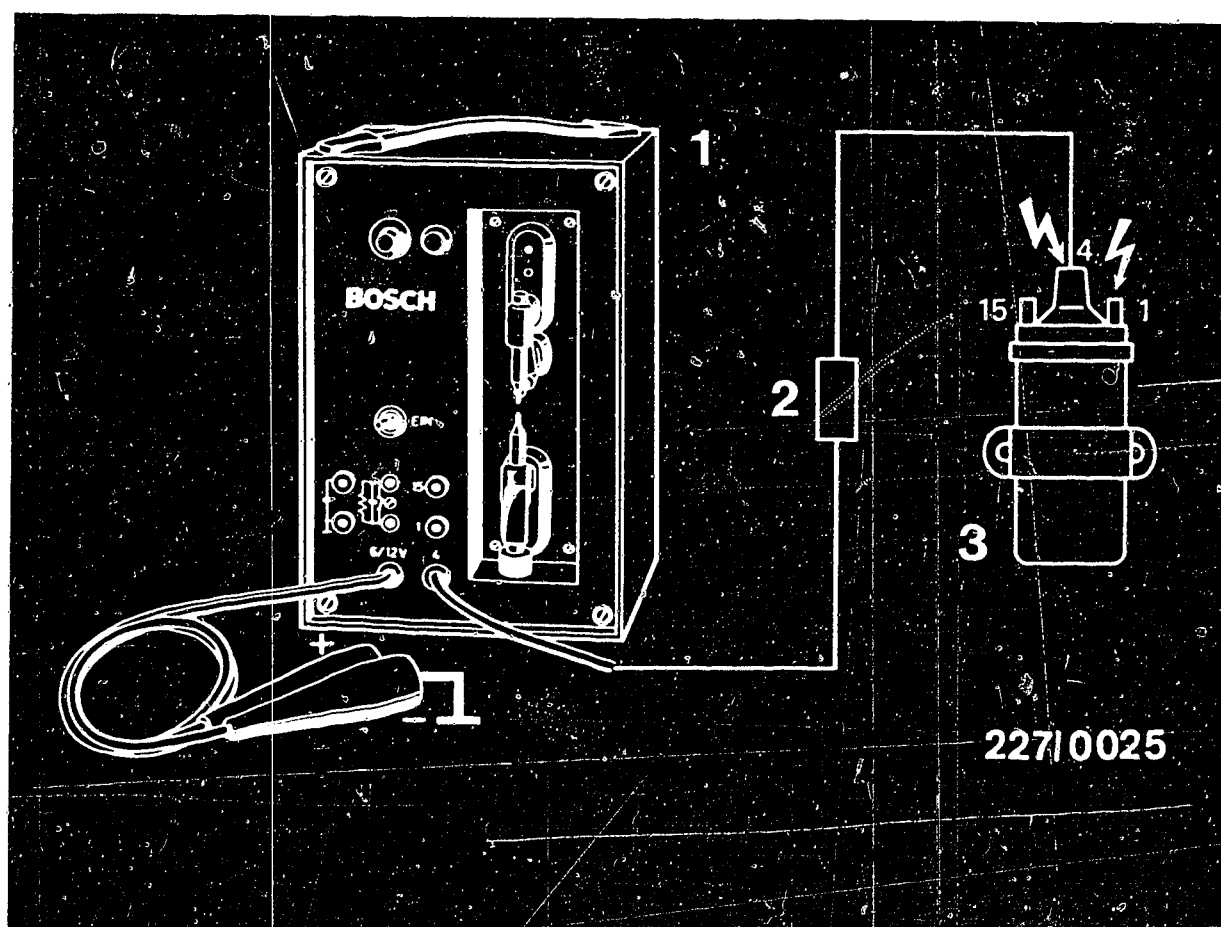
- 1 = Spark gap
- 2 = 5 k $\Omega$  sleeve-type suppressor
- 3 = Ignition coil

- In order to prevent the trigger box from being irreparably damaged, when using a spark gap, an interference-suppression resistor of at least 2 k $\Omega$  must be connected between the spark gap and ignition coil terminal 4, e. g. sleeve-type suppressor (5 k $\Omega$ ) 0 356 500 001.

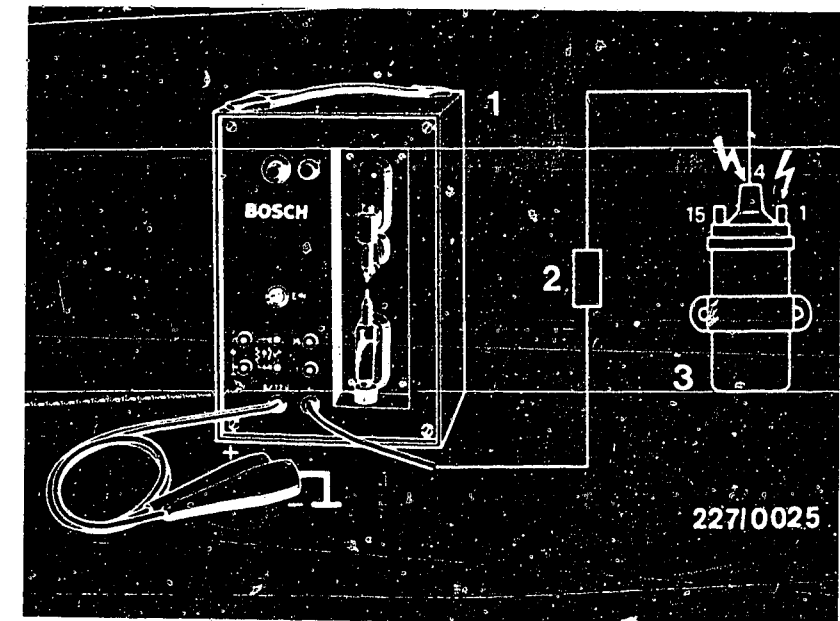
1 = Spark gap  
2 = 5 k $\Omega$  sleeve-type suppressor  
3 = ignition coil

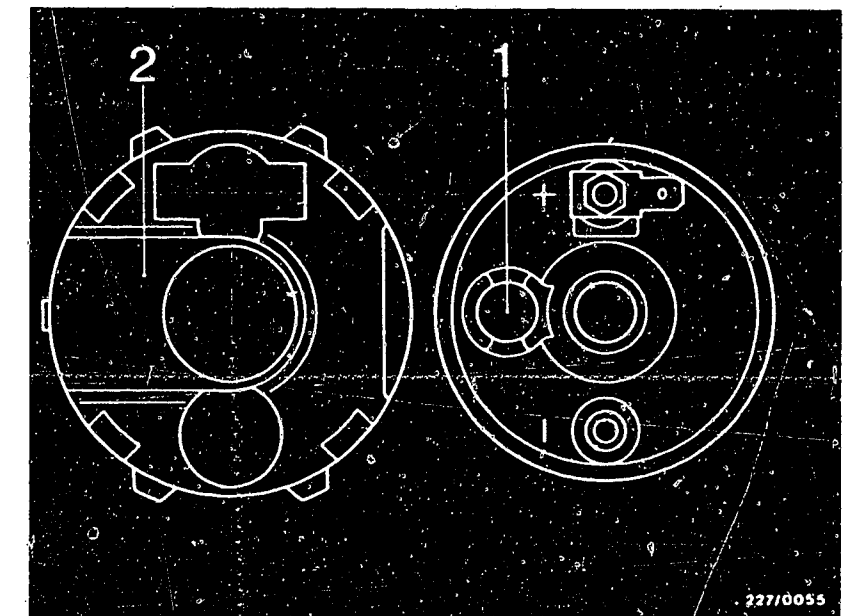
1 = Plug  
2 = Protective cap

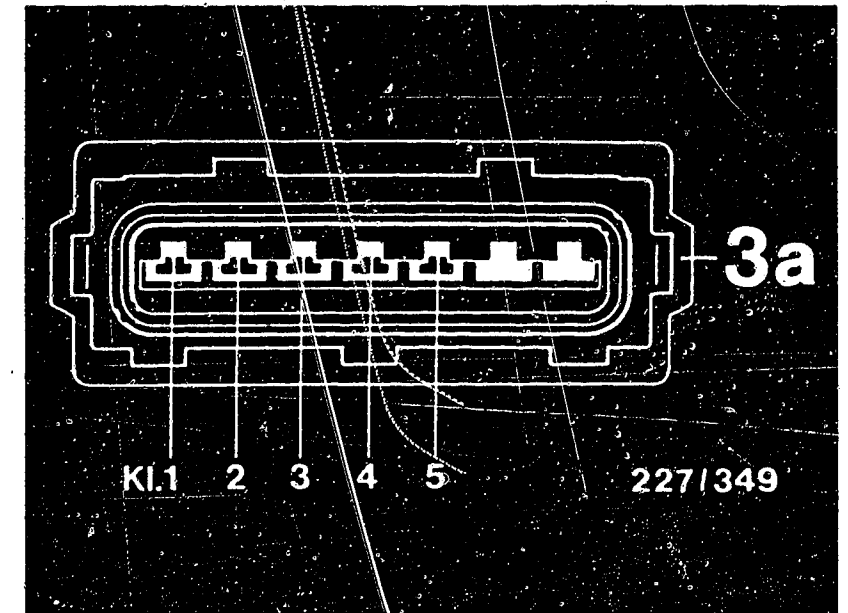
3a = Trigger-box plug

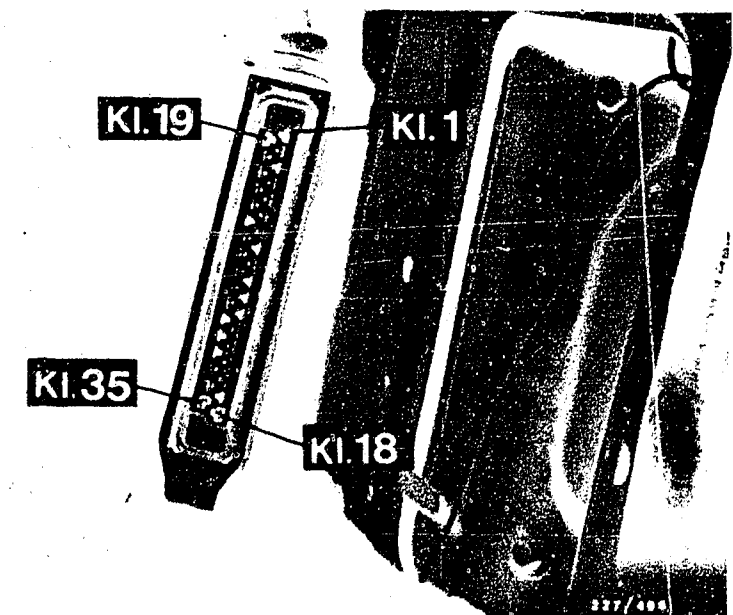
In each instance, the ohmmeter must indicate approx. 0  $\Omega$  (continuity). Eliminate any break.

Ecotronic control unit plug  
KI. = Term.

Timing advance device plug

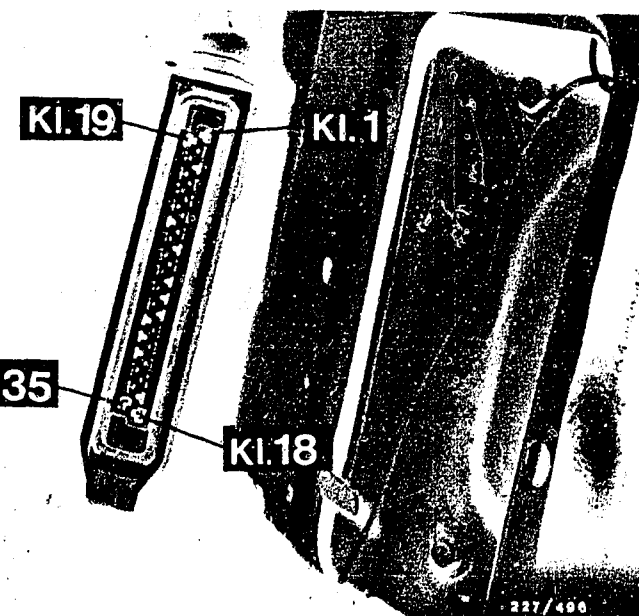
Ecotronic control unit plug  
KI. = Term.

Timing advance device plug

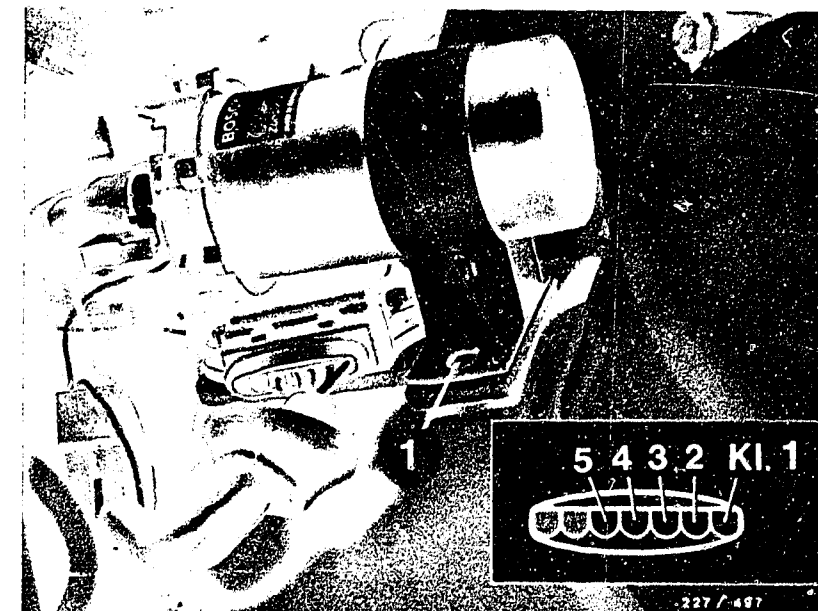
Contact resistance max. 0.3  $\Omega$ . (Take resistance of test lead with test prods into account).

1 = Ignition coil with cooling plate

3a = Trigger-box plug

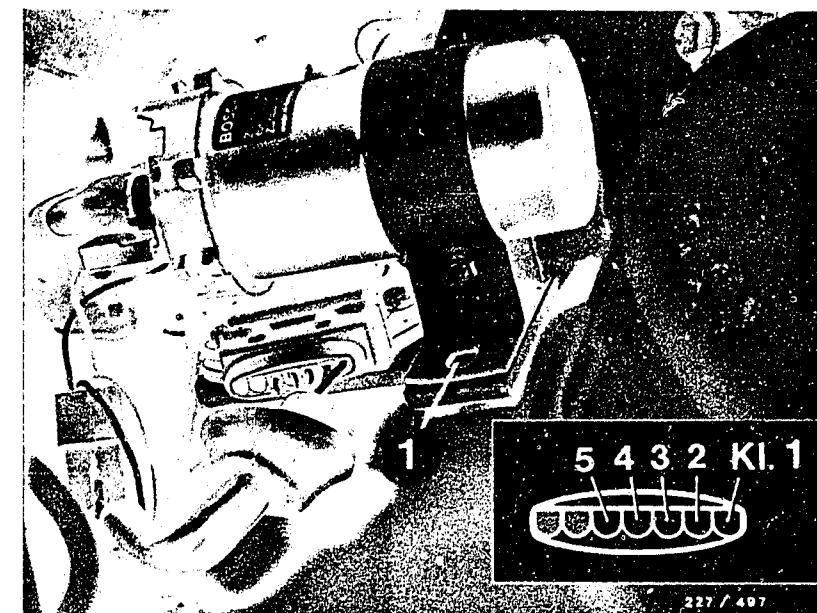
3a = Trigger-box plug

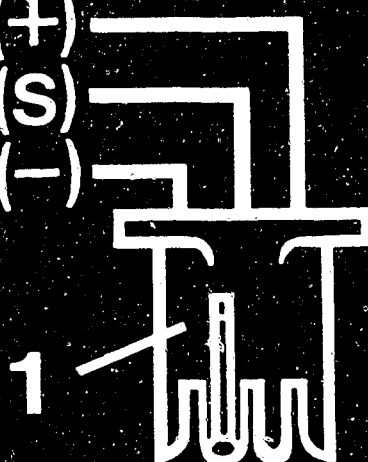
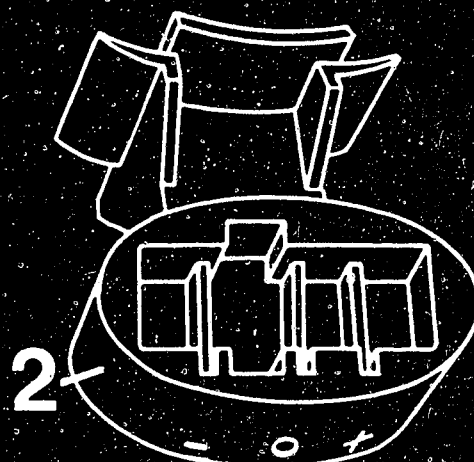
227/357

1 = Ignition-distributor connector

Remove the ignition-distributor connector (see picture) and check contacts for oxidation and correct latching (remedy defects).

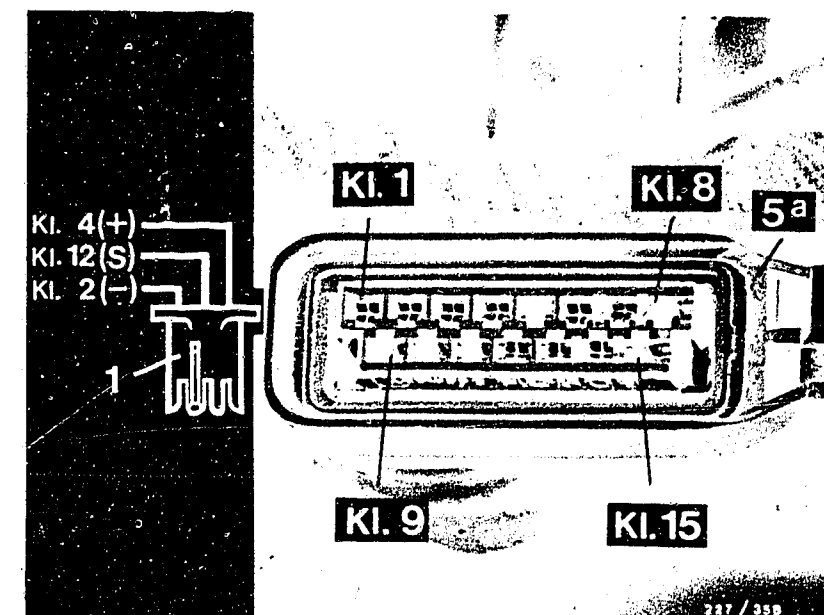
1 = Ignition-distributor connector  
5a = Ignition timing unit plug

3a = Trigger-box plug

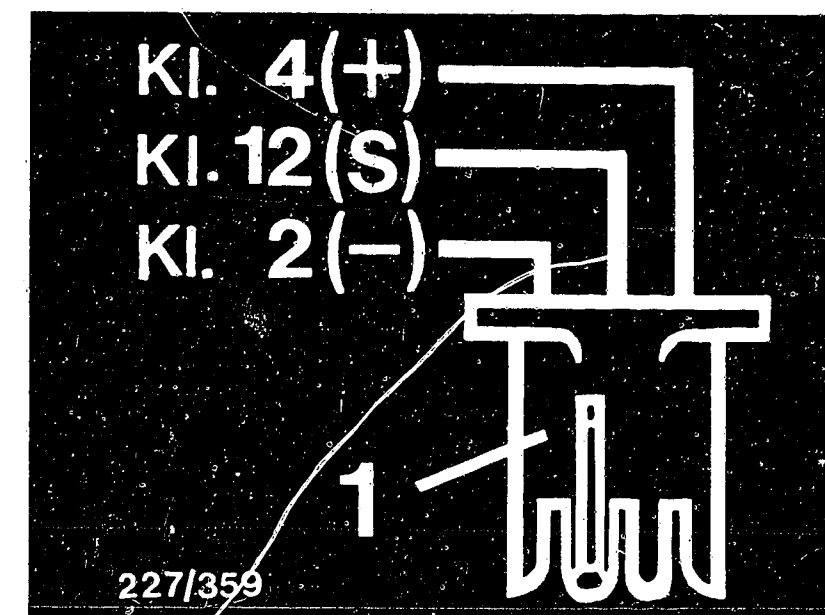
1 = Ignition-distributor connector

Rectangular pulse

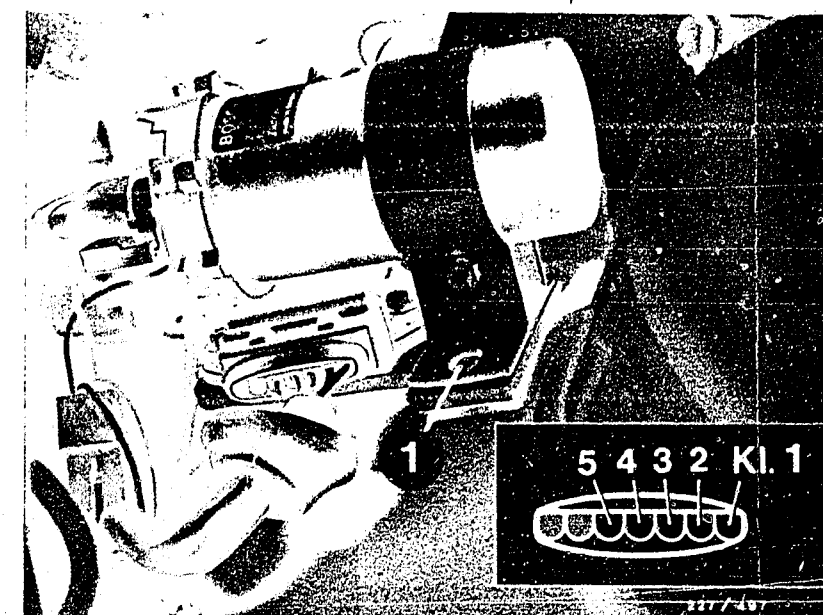
3a = Trigger-box plug

Rectangular pulse

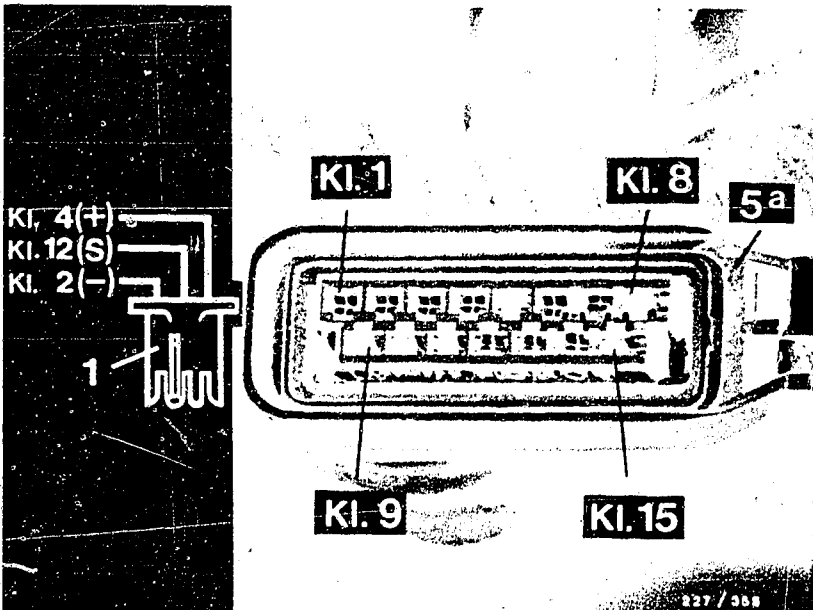
1 = Ignition-distributor connector  
5a= Ignition timing unit plug

3a= Trigger-box plug

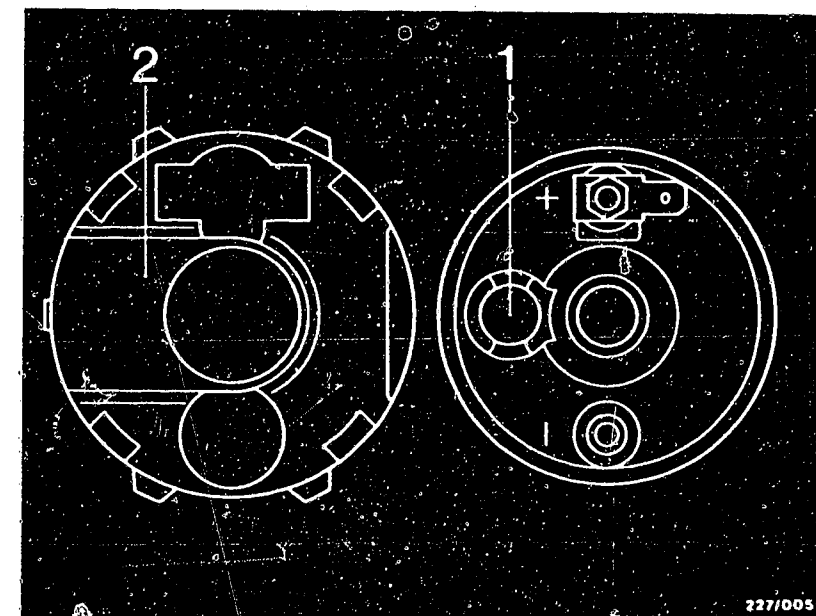
1. If plug is not in position and/or sealing compound has escaped, replace trigger-box, ignition timing unit and ignition coil.

1 = Plug  
2 = Protective cap

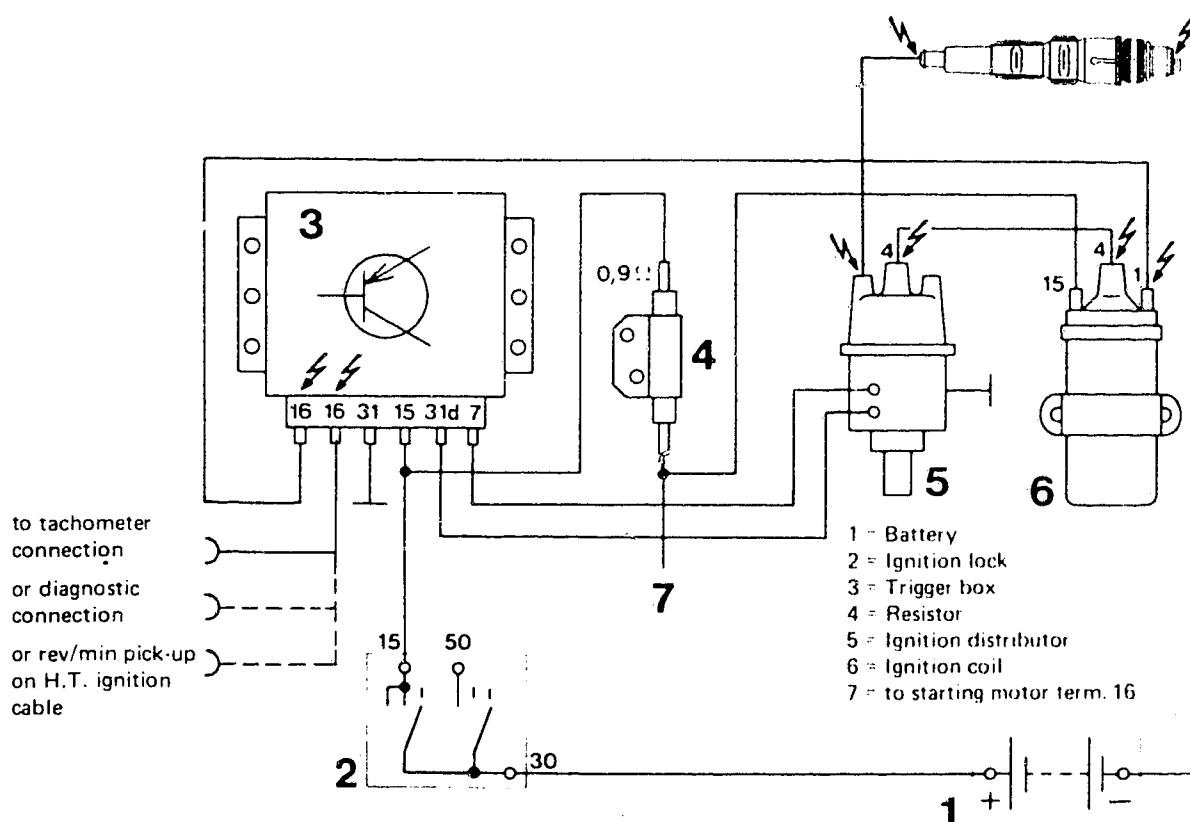
Terminal diagram

Below is a typical terminal diagram of a semi-conductor ignition system, the danger points are marked with red high-voltage arrows. We would point out that all semi-conductor ignition systems, even the older ones, are to be regarded as dangerous in the sense as defined by this bulletin.

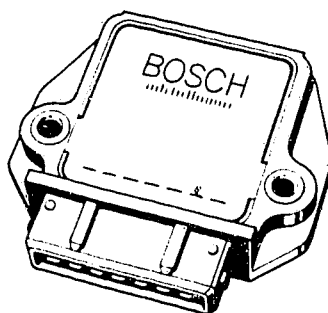
Fig. 1

Apart from the well-known TCI trigger boxes 0 227 100 0.., trigger boxes of hybrid construction have been fitted as standard since 9.78 (Fig. 1).

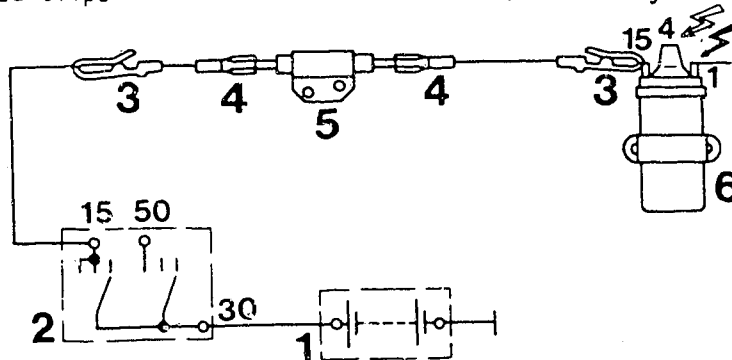
- 1 = Battery
- 2 = Ignition switch
- 3 = Clips

- 4 = Blade receptacle
- 5 = Ballast resistor
- 6 = Ignition coil

Connect a ballast resistor of 0.9 or 1.0 Ohm (see Fig.) in series in the line to term. 15 of the ignition coil (take care not to cause a short circuit). After the rotational-speed measurement, the ballast resistor must be removed (otherwise starting difficulties and misfiring). Connect tester as per operating instructions.

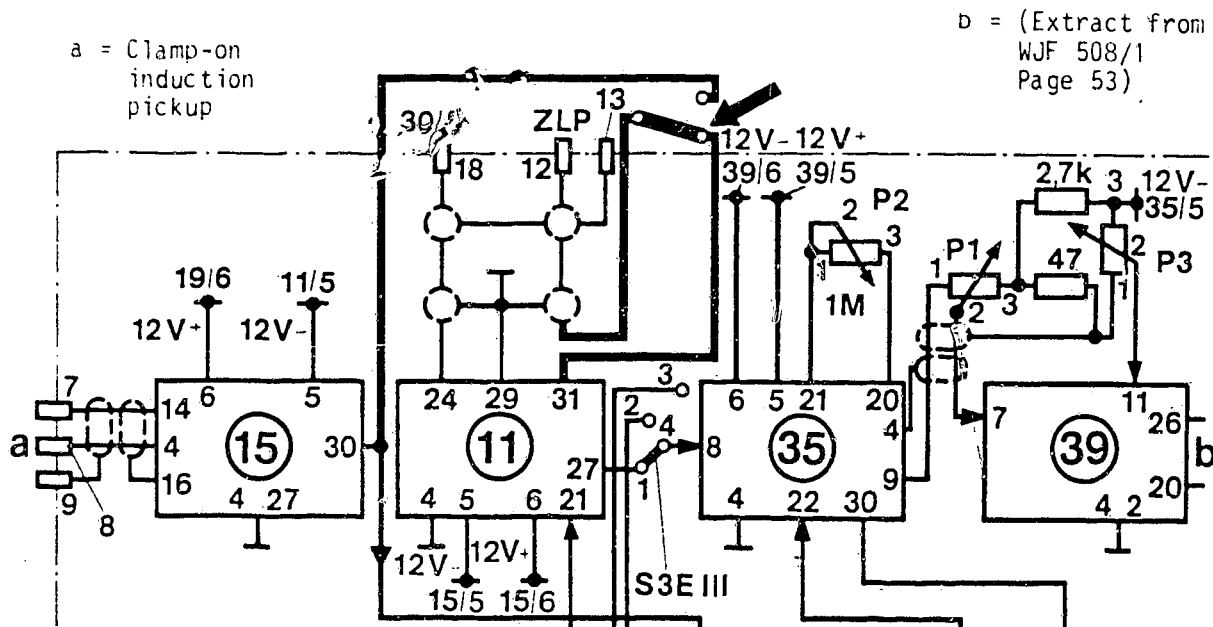
Remove the line of the ZLP\* from pin 31 of printed board 11 (coupling stage) and connect to pin 30 of printed board 15 (pulse shaper stage) via a switch with change-over contact (e.g. 0 341 500 803). In addition, a new line must be connected from pin 31 of printed board 11 to the other contact of the switch with change-over contact. Arrow points to switch with change-over contact.

\* ZLP = timing light

By fitting the switch with change-over contact in the front panel of the motor-tester, it is possible to switch over from standard ignition systems to those with current limitation. We recommend that the switch positions be marked correspondingly: e.g. "standard" - "current limitation". These conversion measures have already been published in the K7 information sheet KJF 28/7911.

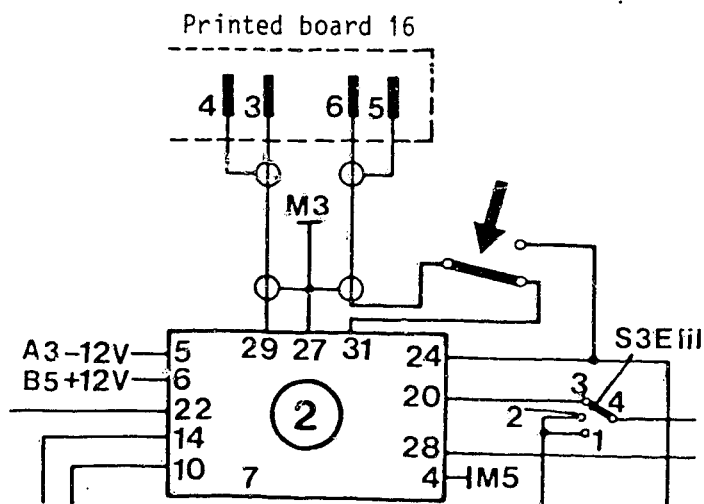
## EFAW 214 B

Remove the line from terminal 6 of printed board 16 to pin 31 of printed board 2 (coupling stage) and connect to pin 24 of the same printed board via a switch with change-over contact (e.g. 0 341 500 803). In addition, a new line must be connected from pin 31 of printed board 2 to the other contact of the switch with change-over contact. Arrow points to switch with change-over contact.
